Debris/Ice/TPS Assessment and Integrated Photographic Analysis of Shuttle Mission STS-77

*Process Engineering/Mechanical System Division/ET-SRB Branch,
Kennedy Space Center, Florida*

**DEBRIS/ICE/TPS ASSESSMENT
AND
INTEGRATED PHOTOGRAPHIC ANALYSIS
OF
SHUTTLE MISSION STS-77**

19 May 1996

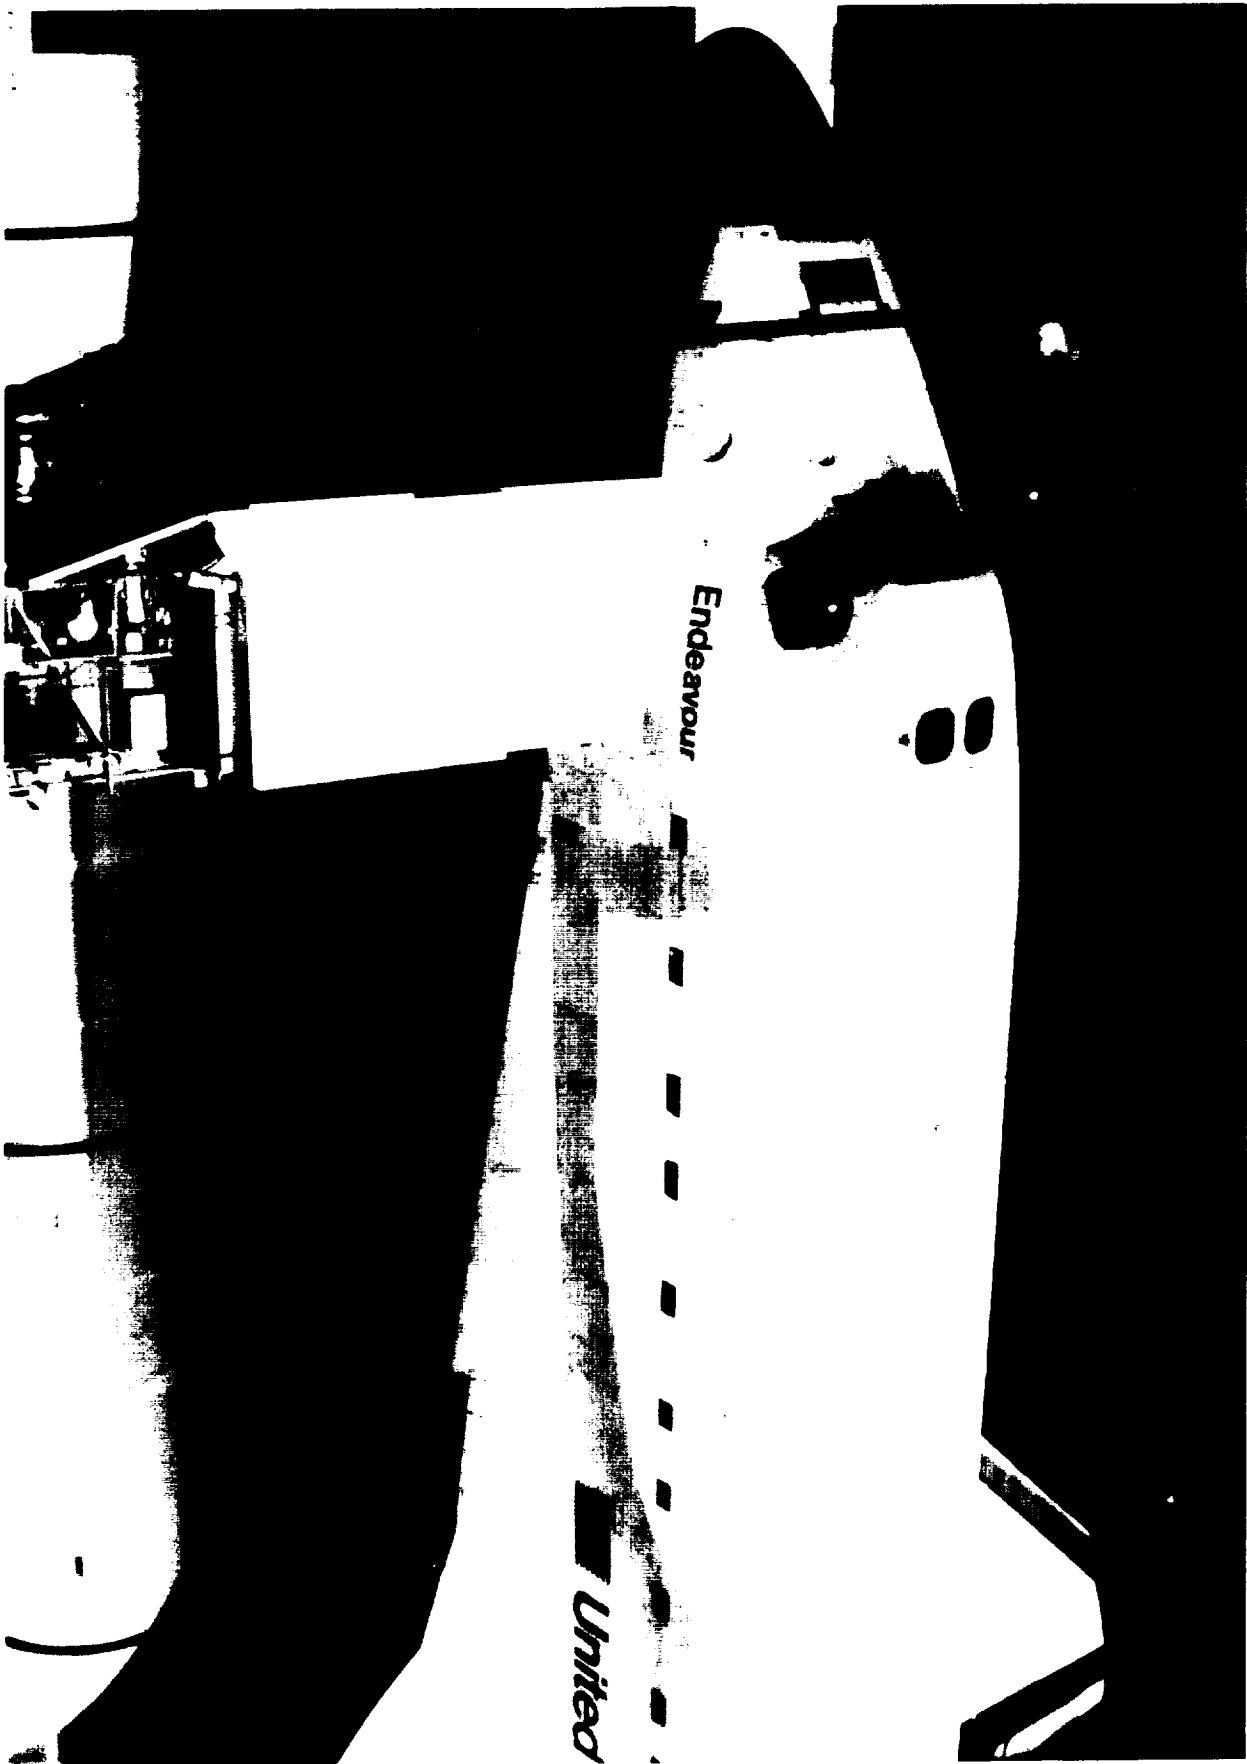
Photo 2: STS-77 Cryoloaded for Launch
OV-105 Endeavour (11th flight), ET-78 (LWT 71), and BI-080 SRBs

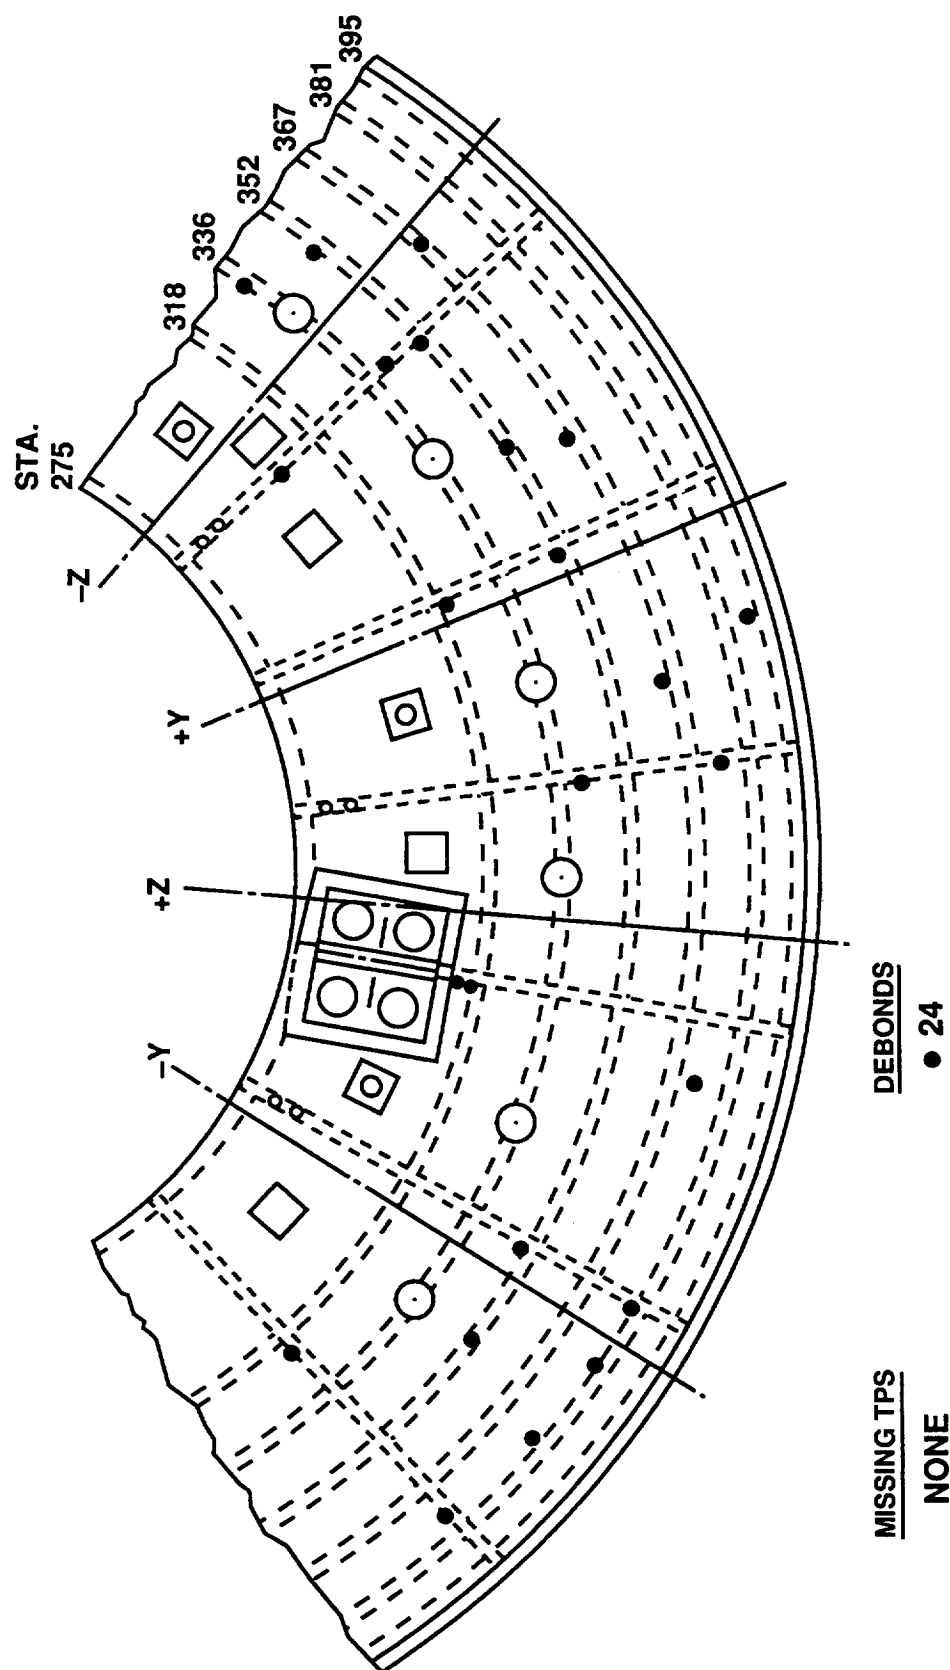
Figure 1: RH SRB Frustum

The RH frustum was missing no TPS. The number of debonds over fasteners (24) was average (Figure 4). Hypalon paint was blistered/missing along the XB-395 ring frame where BTA closeouts had been applied. However, most of the exposed BTA substrate was not sooted. The BSM aero heat shield covers had locked in the fully opened position.

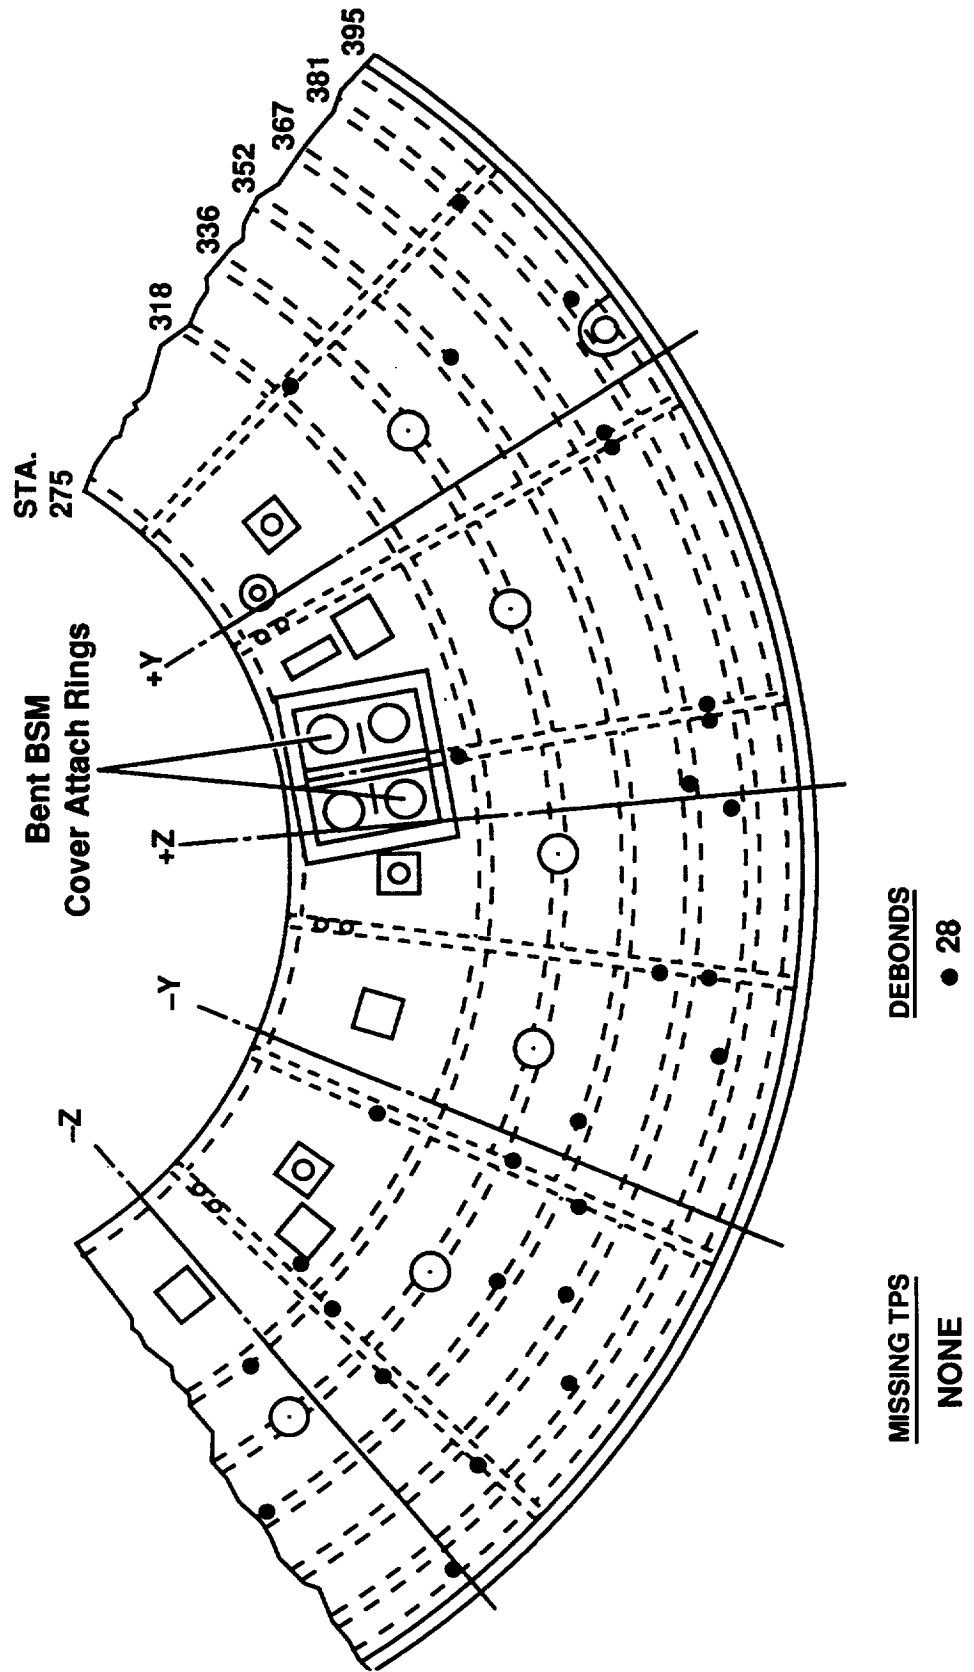
Figure 2: LH SRB Frustum

The LH frustum was missing no TPS. The number of MSA-2 debonds over fasteners (28) was average (Figure 5). Hypalon paint was blistered/missing along the XB-395 ring frame where BTA closeouts had been applied. However, most of the exposed BTA substrate was not sooted. The BSM aero heat shield covers had locked in the fully opened position though the lower left and upper right cover attach rings had been bent by parachute entanglement.

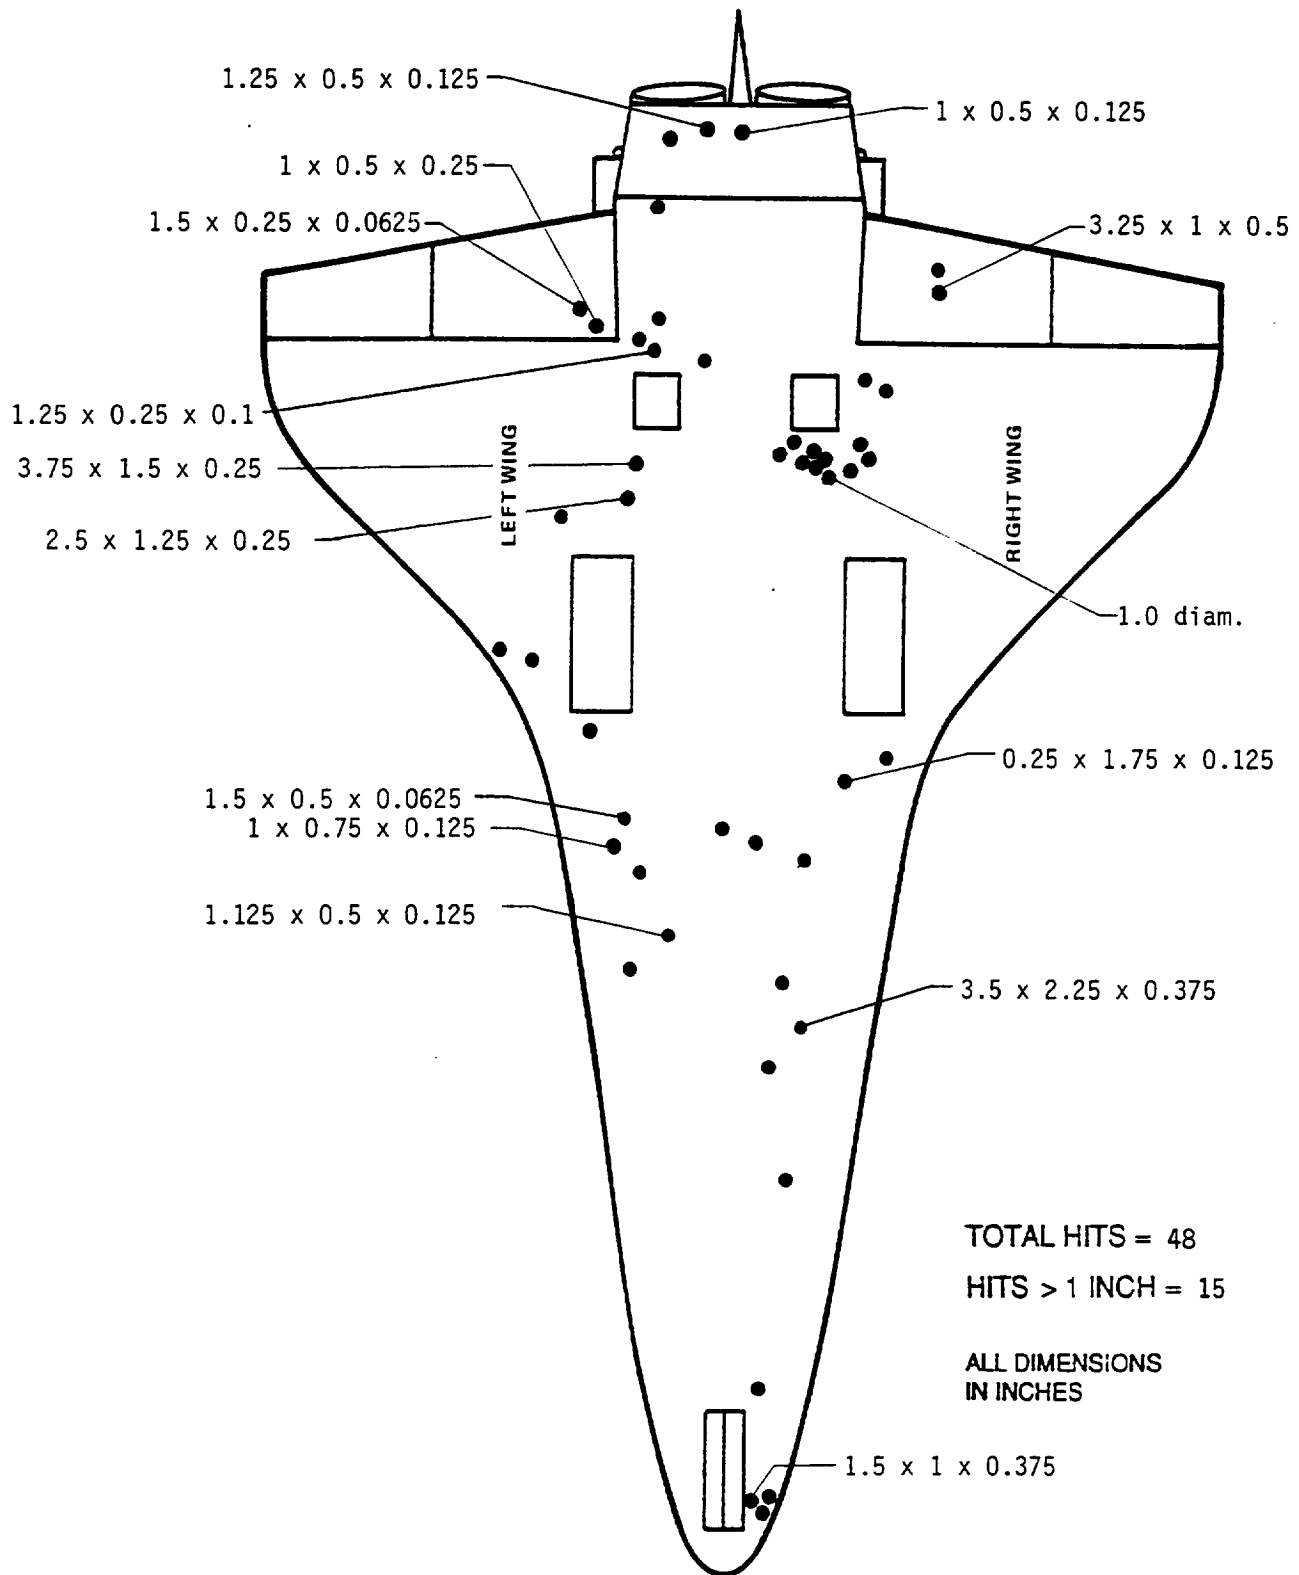
Figure 3: Orbiter Lower Surface Debris Map

The Orbiter lower surface sustained a total of 48 hits, of which 15 had a major dimension of 1-inch or larger. The largest lower surface tile damage site involved three tiles on the right chine and measured 3.5-inches long by 2.25-inches wide by 0.375-inch maximum depth. Hits on the right side along a line from nose to tail are generally attributed to ice impacts from the ET LO2 feedline bellows and support brackets.

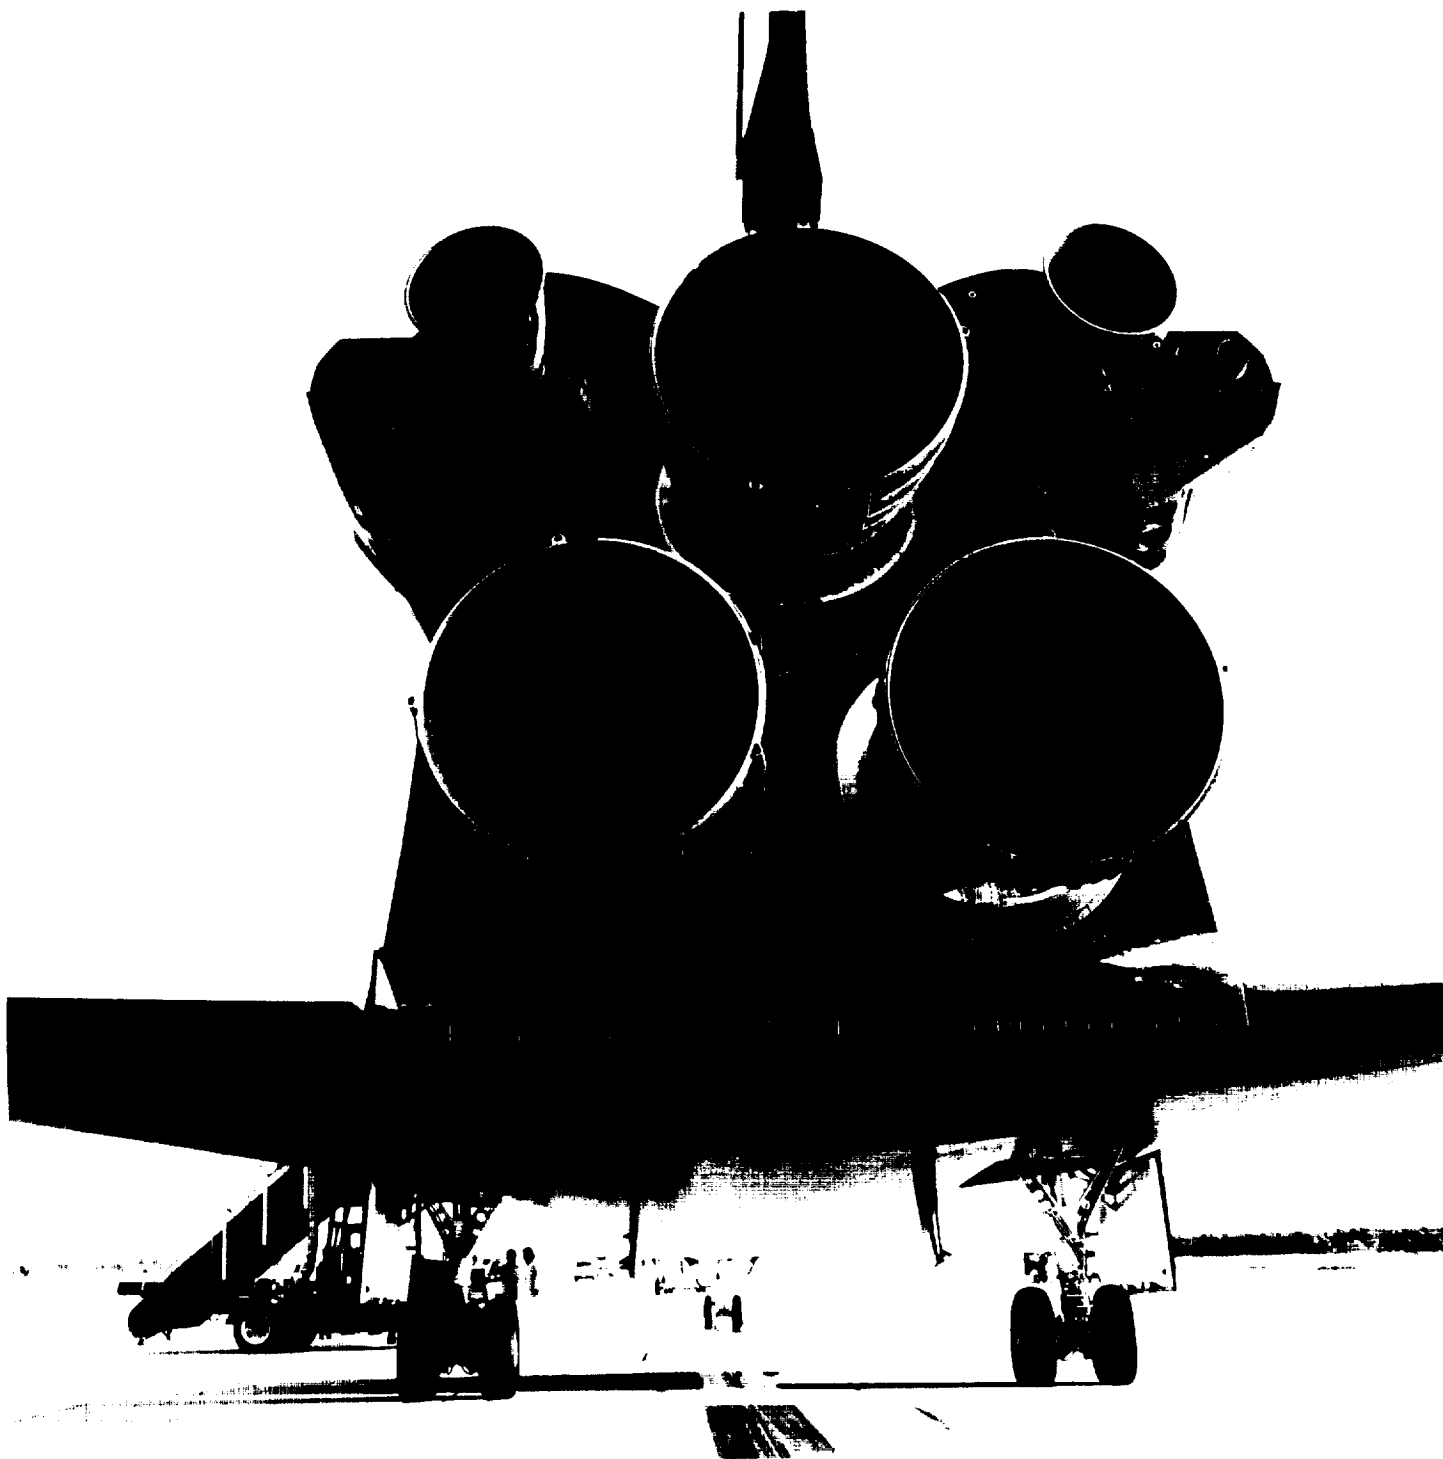
Photo 21: Overall View of Orbiter Base Heat Shield/SSMEs

The SSME #1 and #2 Dome Mounted Heat Shield (DMHS) closeout blankets were torn at the 6:00 o'clock and 2:00-4:00 o'clock locations, respectively. The SSME #3 DMHS was in excellent condition with no missing material. Tiles on the vertical stabilizer stinger and around the drag chute door were intact and undamaged.

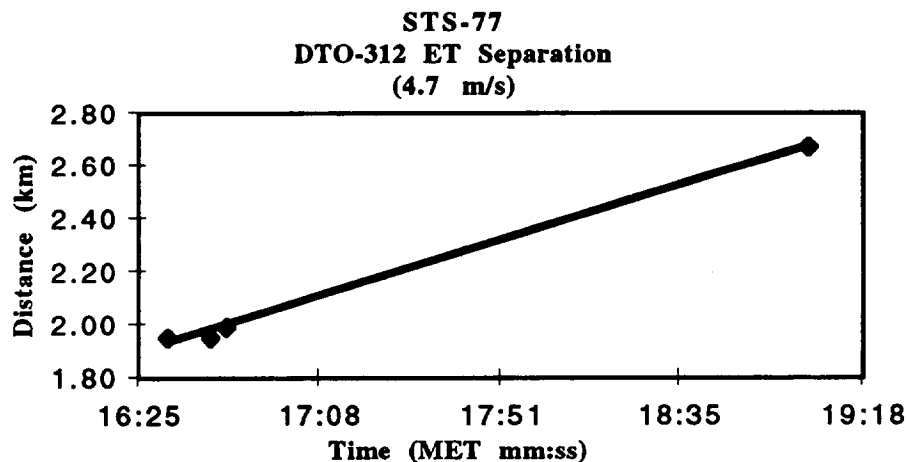
Figure 2.4.2 (B) ET Separation Velocity

The distance of the external tank was calculated over a four frame sequence using the hand held photography. The external tank was calculated to be a distance of 2.0 km away from the Orbiter at 16:32 MET. The tank was calculated 153 seconds later (19:05 MET) to be at a distance of 2.7 km. The tank separation velocity was determined to be 4.7 m/s. The separation velocity was similar to previous mission measurements. The tank tumble and roll velocity were not determined due to insufficient data.

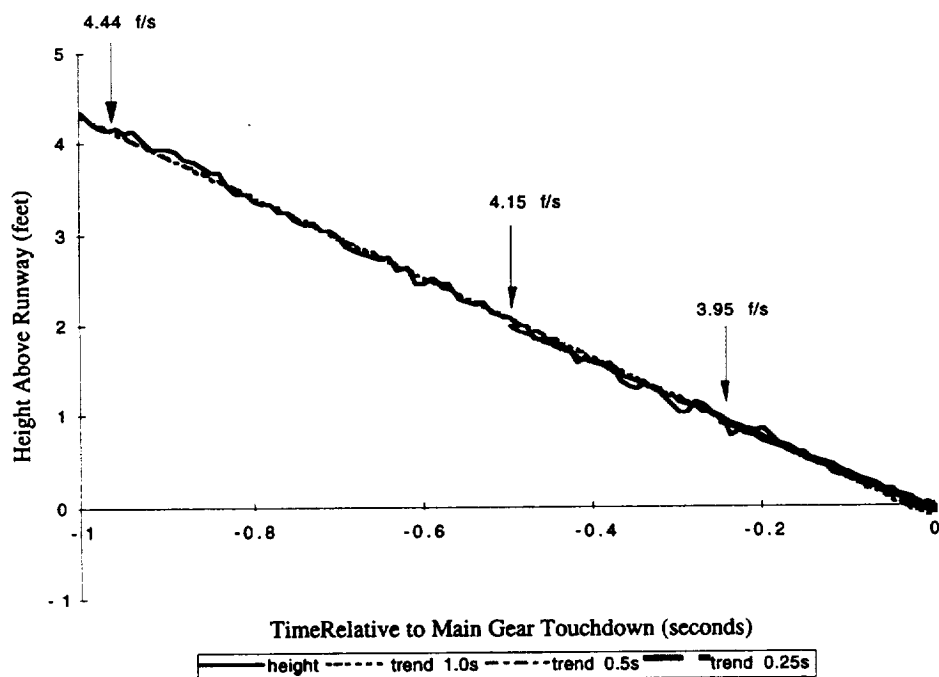
Figure 2.5.1(A) Main Gear Height versus Time Prior to Touchdown (Film)

The measured main gear sink rate values were found to be below the maximum allowable values of 9.6 ft/sec for a 211,000 lb. vehicle and 6.0 ft/sec for a 240,000 lb. vehicle (the landing weight of the STS-77 Orbiter was reported to be 221,910 lb.). The sink rate measurements for STS-77 are given in Table 2.5.1. In Figures 2.5.1(A), and 2.5.1(B), the trend of the measured data points for film image data is illustrated.
